AFRL-ML-WP-TR-2001-4020

**LIFE PREDICTION METHODOLOGIES FOR
AEROSPACE MATERIALS**

**UNIVERSITY OF DAYTON RESEARCH INSTITUTE
STRUCTURAL INTEGRITY DIVISION
300 COLLEGE PARK
DAYTON, OHIO 45469-0128**

INTERIM REPORT FOR PERIOD 25 MAY 1999 - 24 MAY 2000

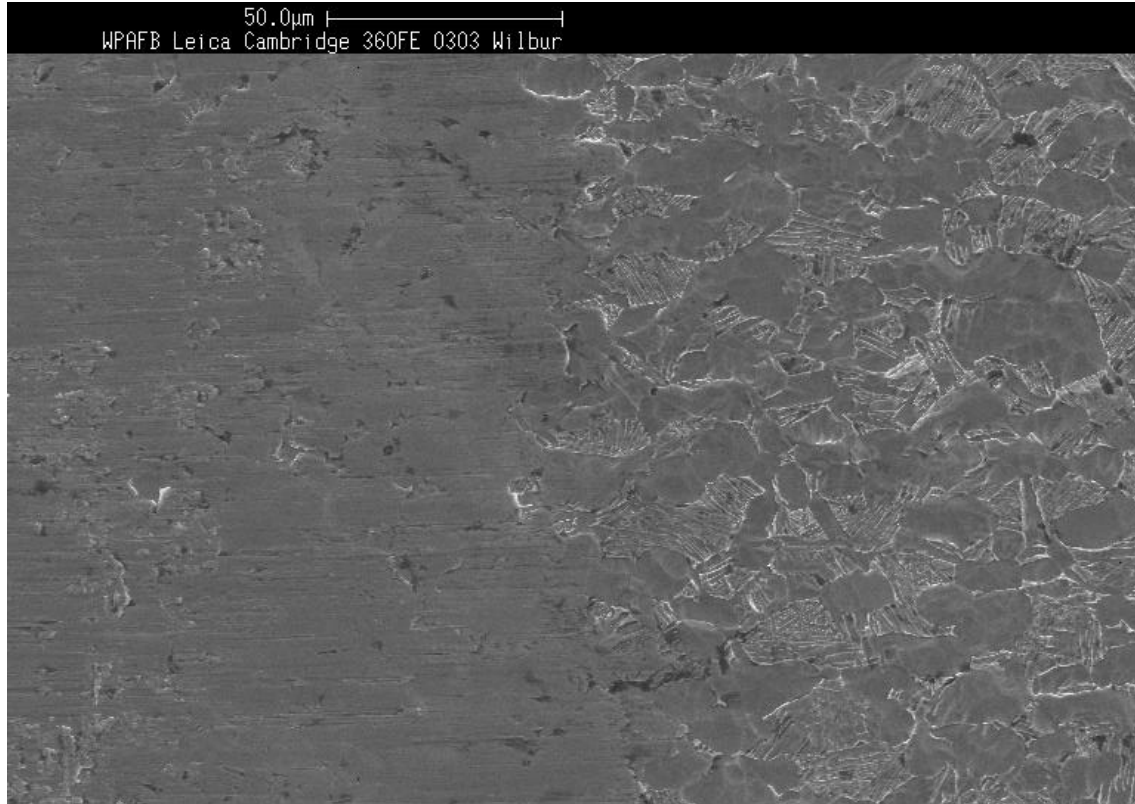
Figure 1. Fretted Region from 94-11. Unfretted surface is shown in the right half; the fretted surface is shown in the left half.

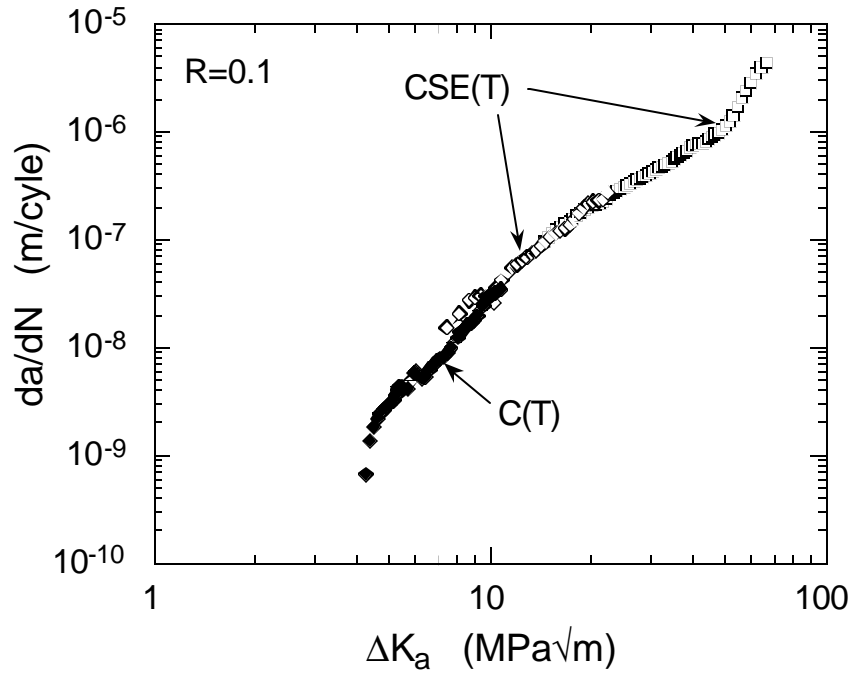
Figure 1. Crack growth behavior of neat TIMETAL®21S at 23°C and R=0.1. Thickness of specimens = 0.86 – 0.99 mm.

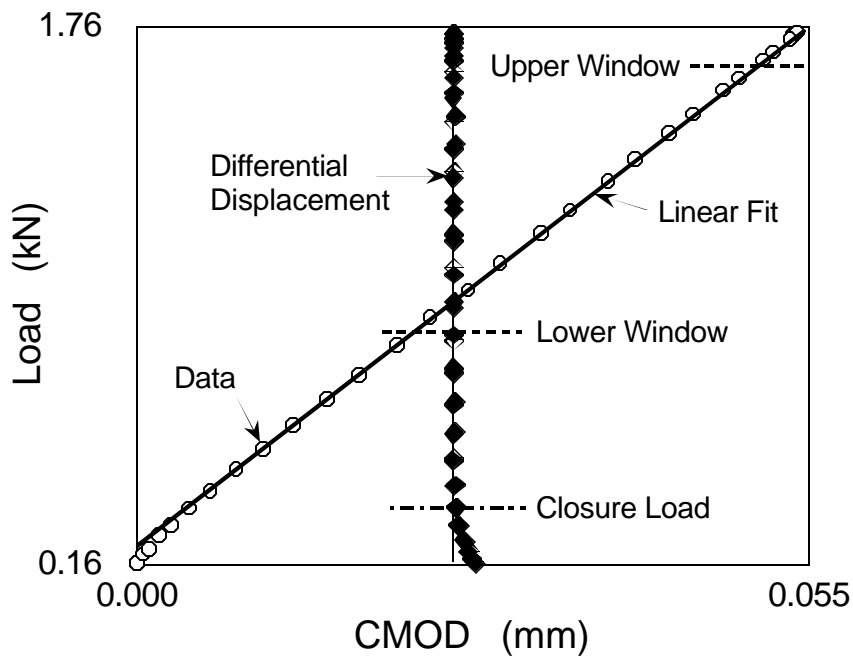
Figure 2. Typical load versus CMOD response of neat TIMETAL®21S at R=0.1. Only 3% of 1000 data points are shown.

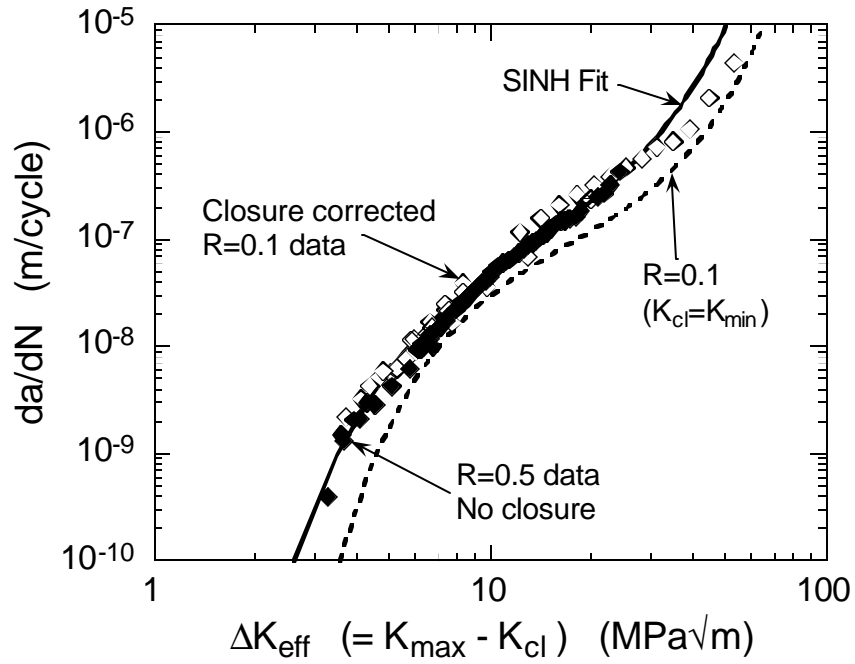
Figure 4. Closure corrected crack growth behavior of neat TIMETAL®21S.

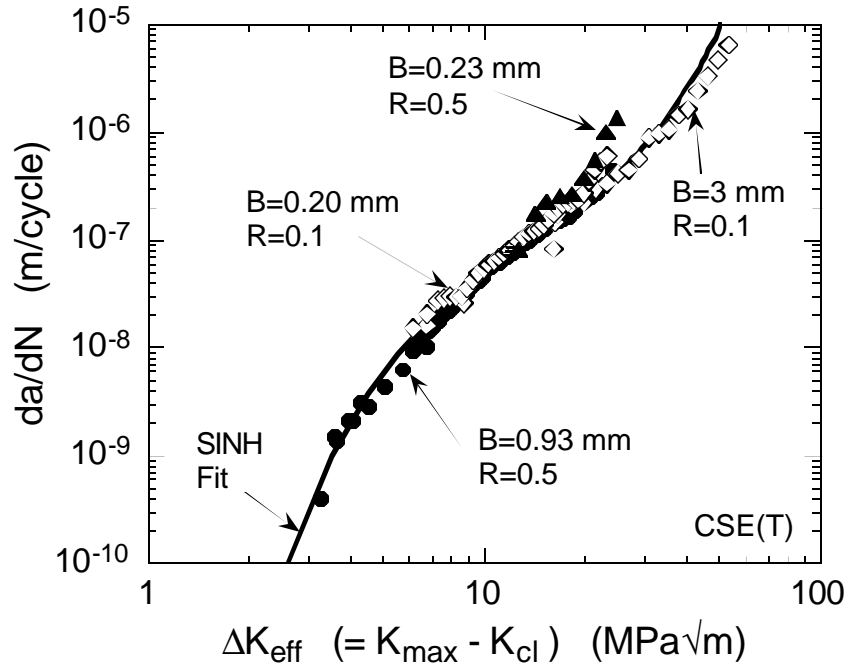
Figure 5. Effect of thickness (B) on crack growth behavior of neat TIMETAL®21S.

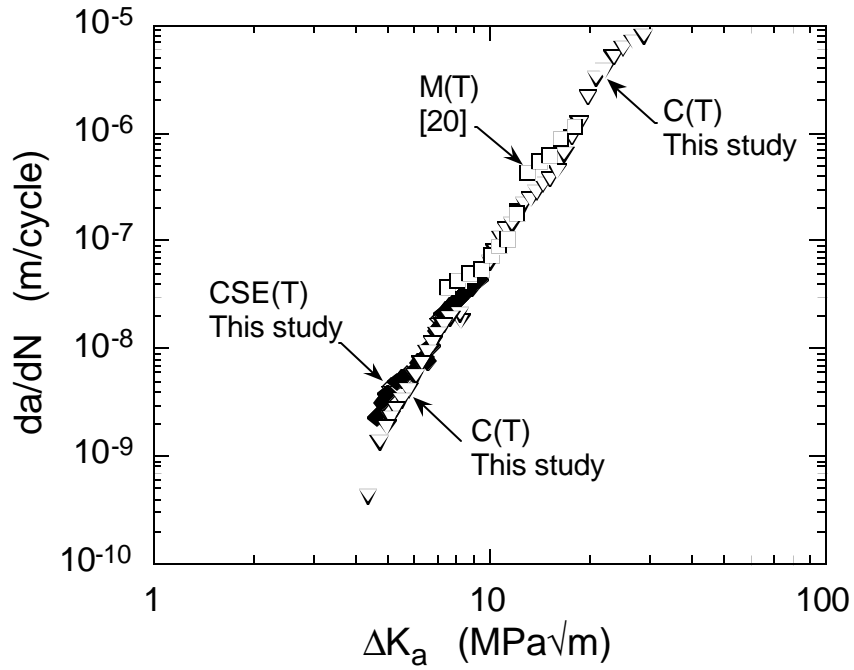
Figure 6. Crack growth behavior of $[90]_4$ SCS-6/TIMETAL®21S for different geometries at $R=0.1$.

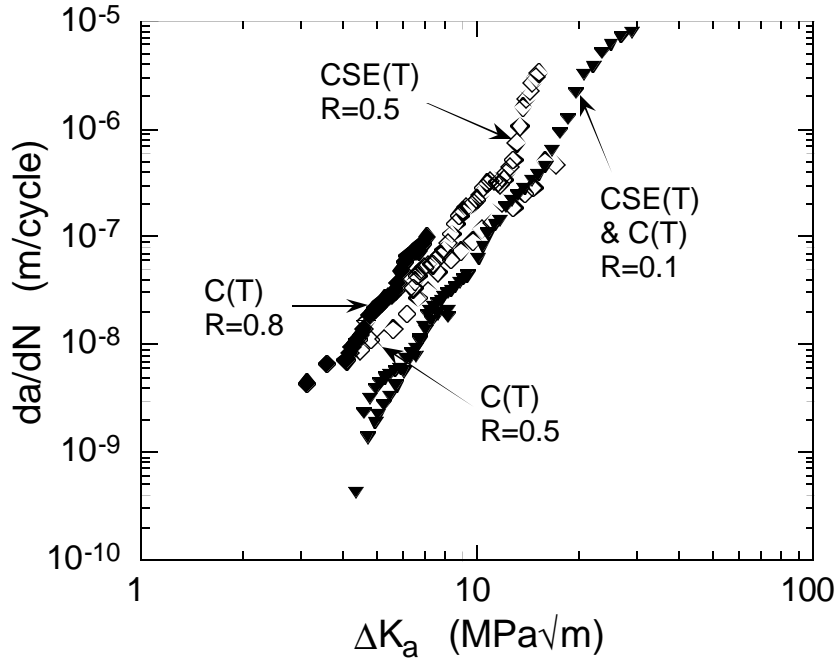
Figure 7. Effect of stress ratio (R) on crack growth behavior of $[90]_4$ SCS-6/TIMETAL®21S.

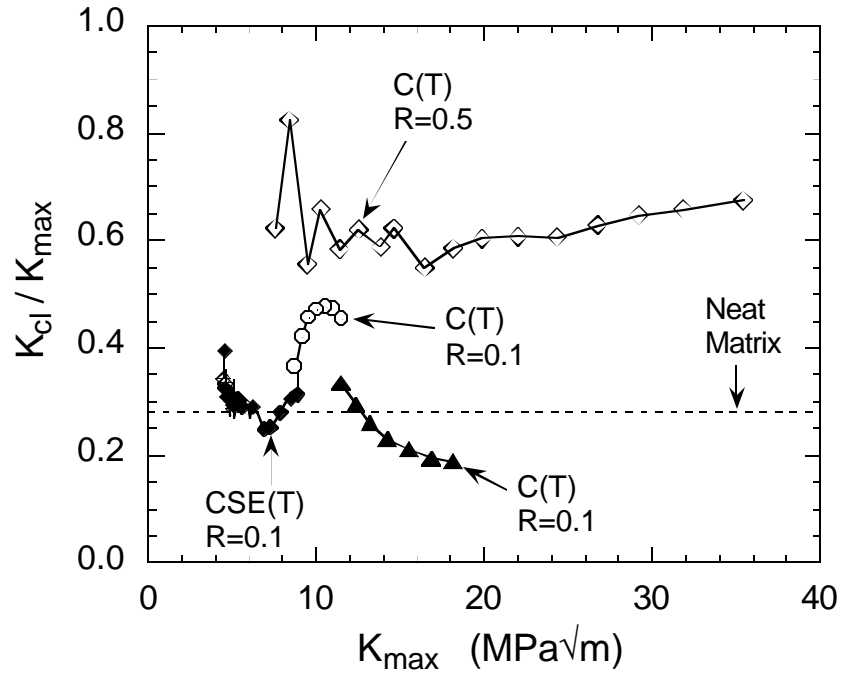
Figure 8. Ratio of closure stress intensity factor (K_{cl}) to maximum stress intensity factor (K_{max}) versus K_{max} for $[90]_4$ SCS-6/TIMETAL®21S.

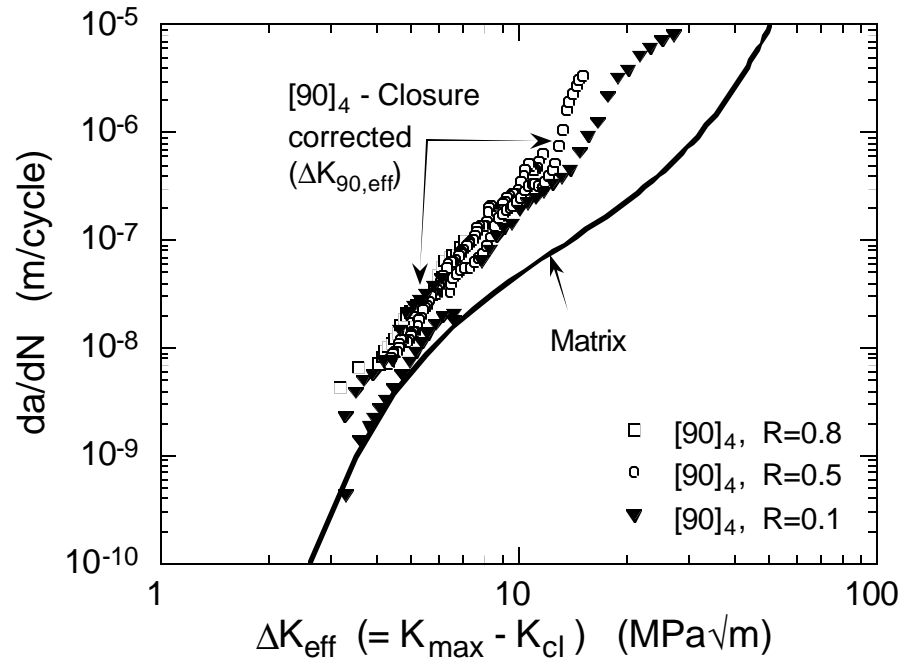
Figure 9. Closure corrected crack growth behavior of $[90]_4$ SCS-6/TIMETAL®21S.

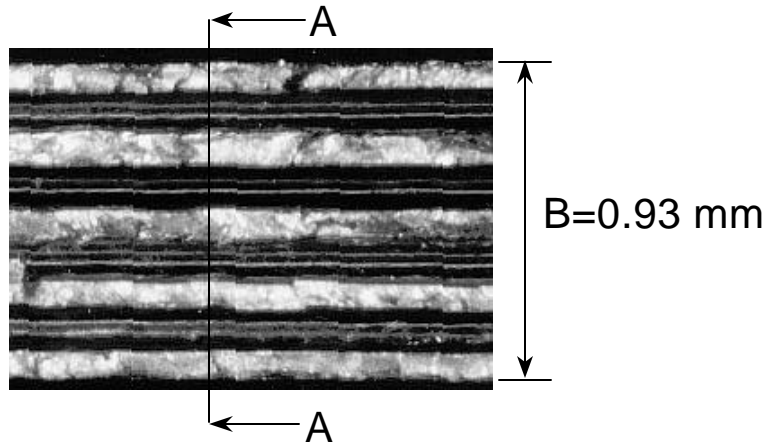
Figure 10. Fracture surface of $[90]_4$ SCS-6/TIMETAL®21S.

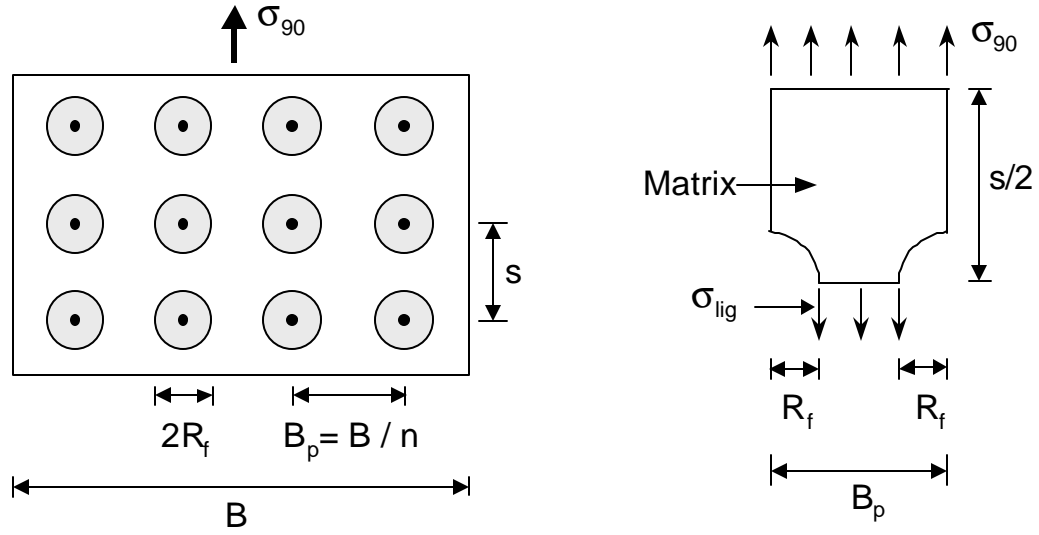
Figure 11. Schematic of [90] composite and the net section between the fibers. n = number of plies (=4 in this study).

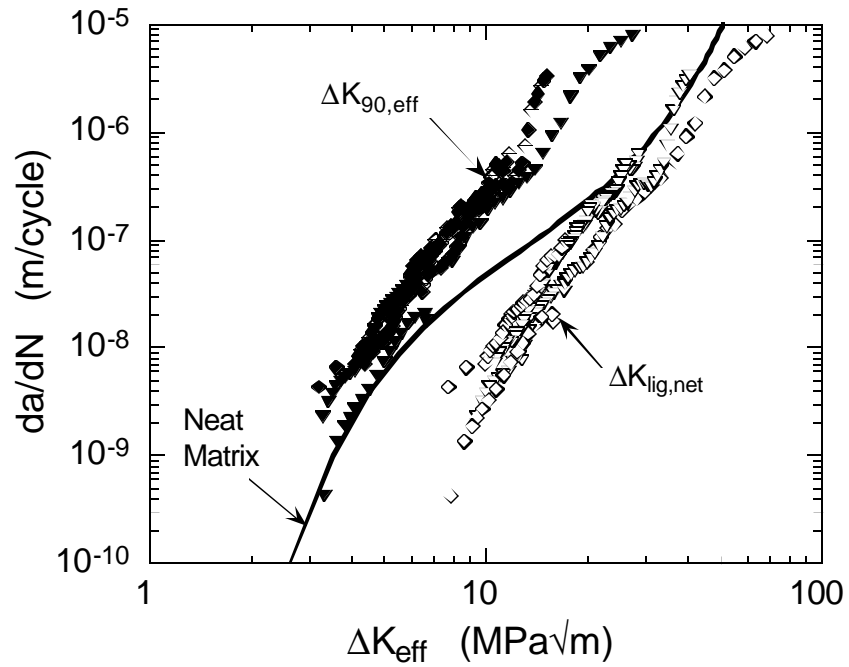
Figure 12. Net-section adjusted crack growth behavior of [90]₄ SCS-6/Timetal®21S. Solid and hollow symbols correspond to $\Delta K_{90,eff}$ and $\Delta K_{lig,net}$, respectively.

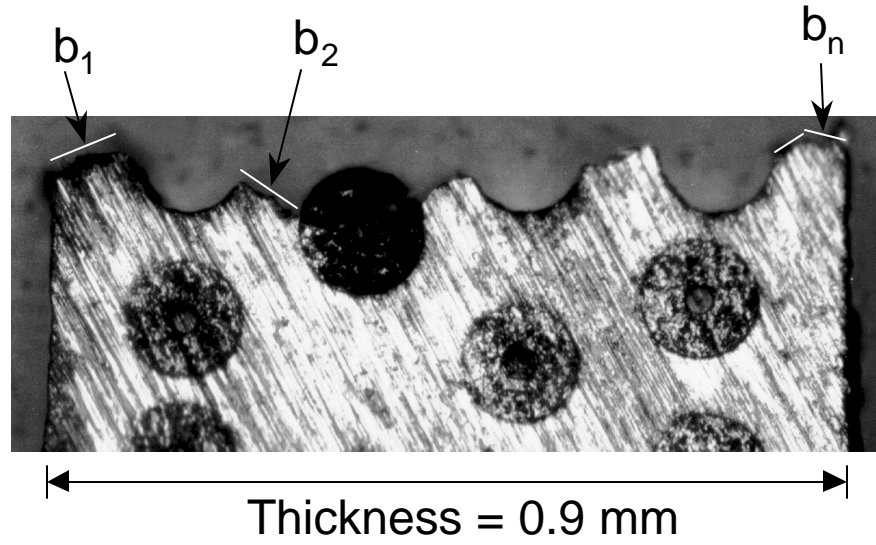
Figure 13. Typical fracture profile highlighting the non-planar fracture surface.

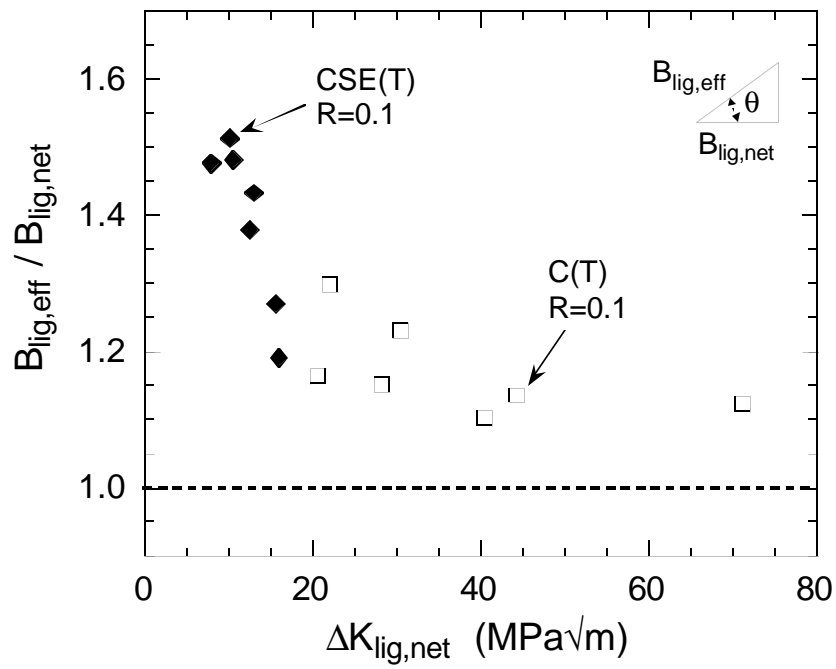
Figure 14. Ratio of effective ligament to narrowest ligament thickness, $B_{\text{lig,eff}} / B_{\text{lig,net}}$ versus $\Delta K_{\text{lig,net}}$. Note that $B_{\text{lig,net}} = B_{\text{lig,eff}} \cos \theta$.

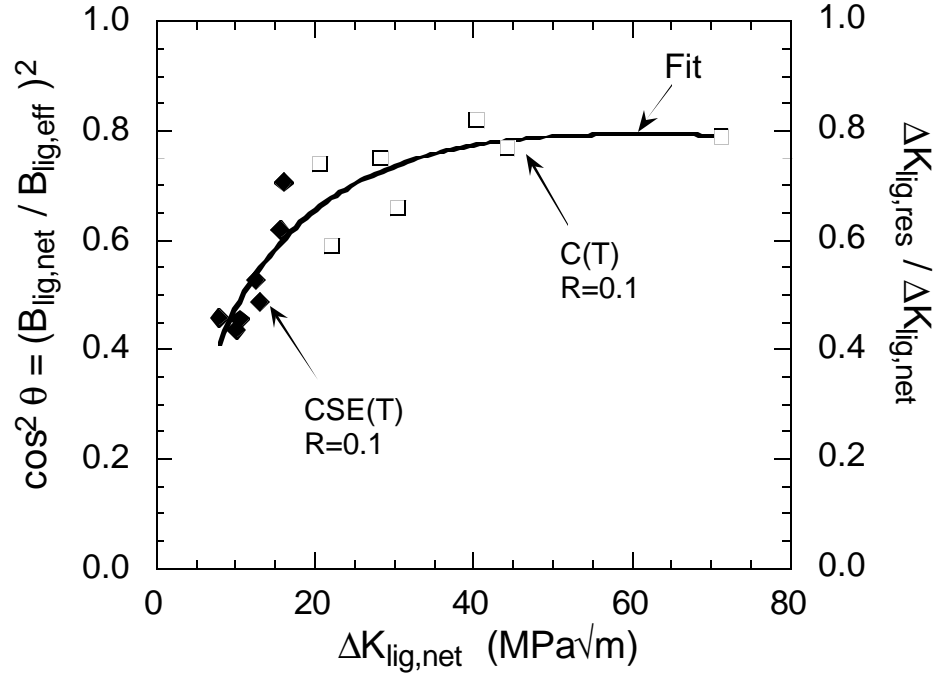
Figure 15. Correction factor for $\Delta K_{lig,net}$ due to the non-planar fracture surface.

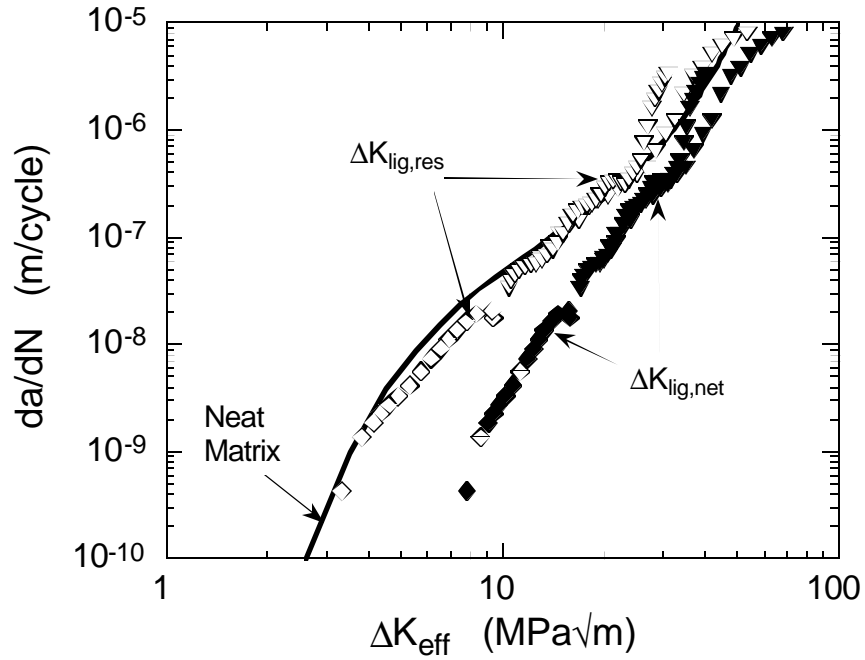
Figure 16. Correlation between closure-corrected crack growth behavior of [90]₄ SCS-6/TIMETAL®21S with that of neat TIMETAL®21S. $\Delta K_{lig,net}$ corresponds to the net-section method and $\Delta K_{lig,res}$ to the effective ligament method.

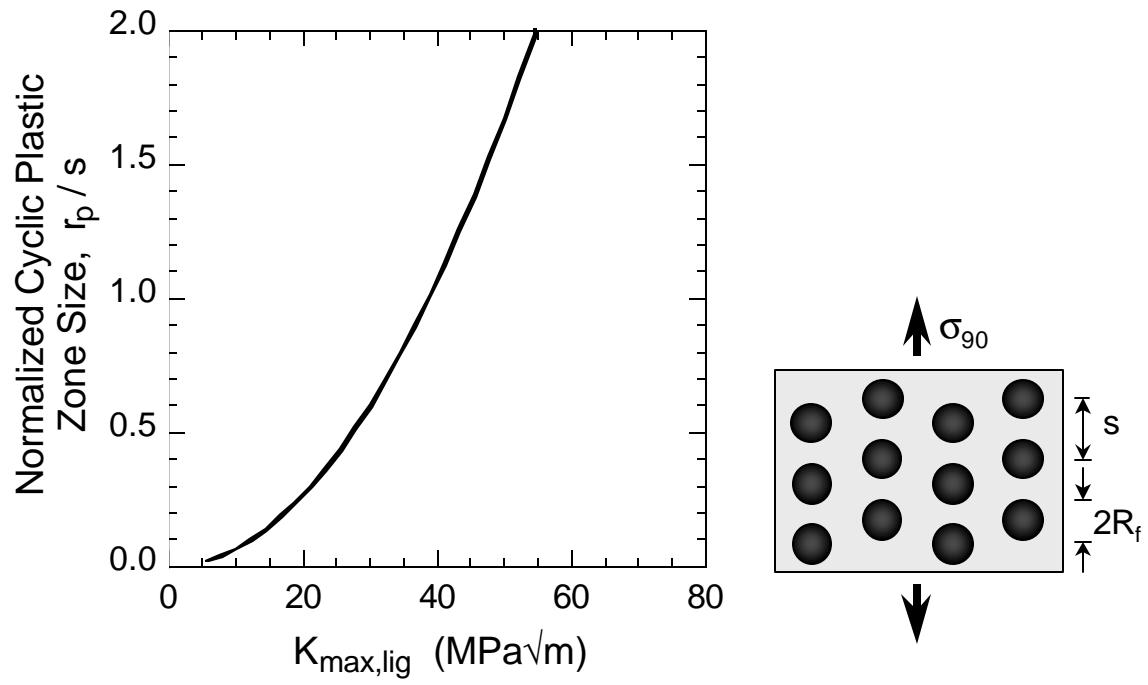
Figure 17. Relationship between plastic zone, fiber spacing and applied stress intensity factor in the matrix ligament in the $[90]_4$ composite.

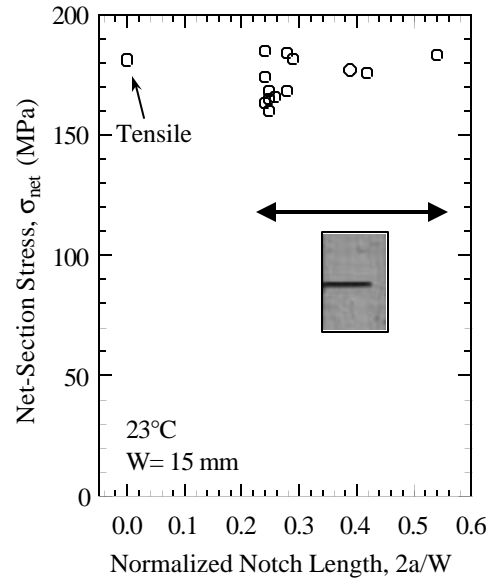
Figure 6. Effect of notch length on net-section strength.

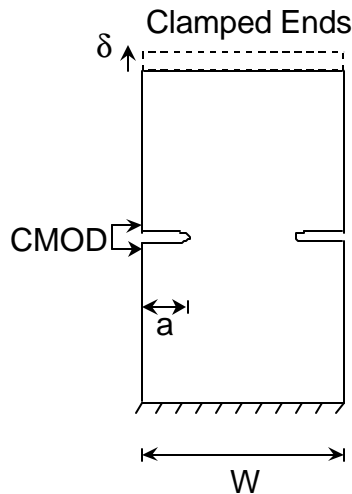
Figure 2. Schematic of the double edge notched geometry.

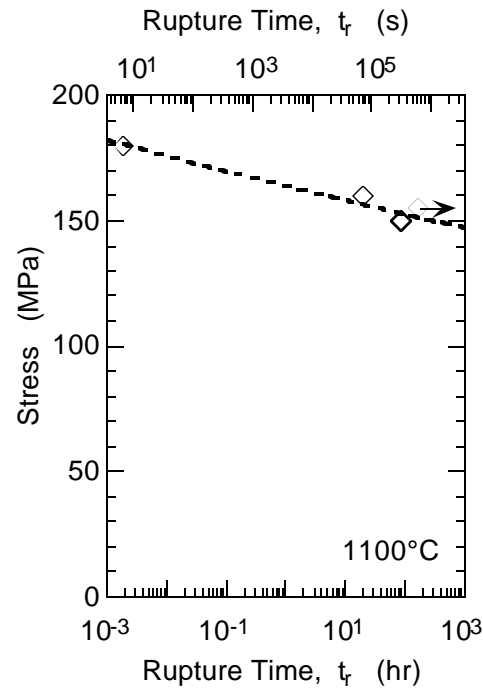
Figure 5. Creep behavior of unnotched Nextel720/AS.

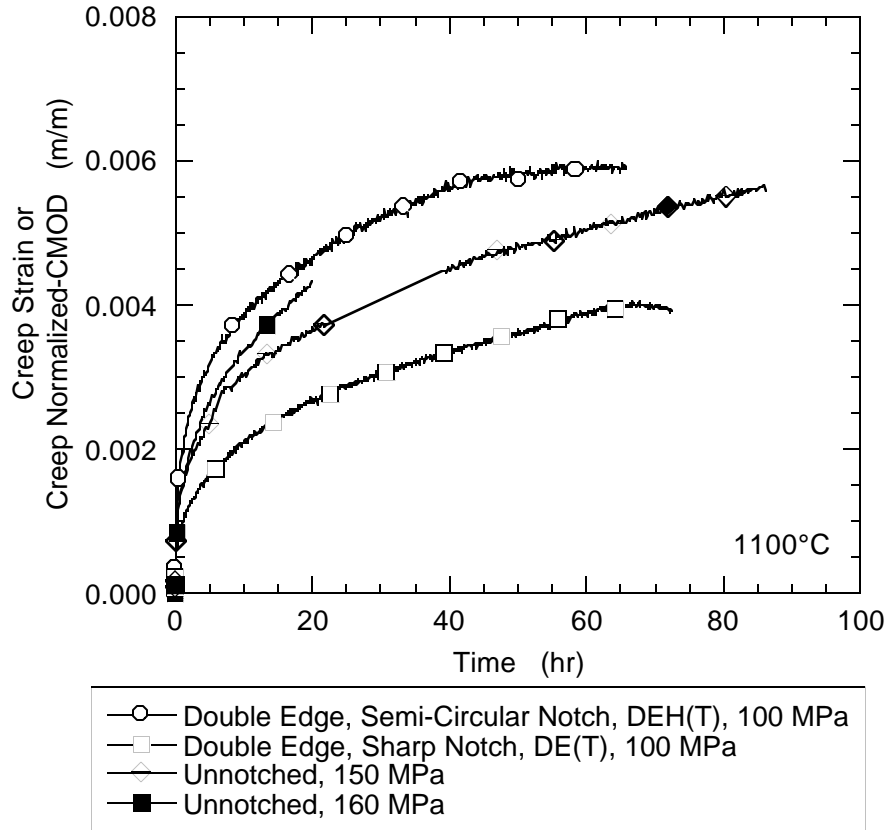
Figure 6. Creep response of unnotched and notched Nextel720/AS (1100°C).

Figure 6 shows the creep response of unnotched and notched Nextel720/AS. The stress levels for the notched specimens, i.e. DE(T) and DEH(T), correspond to the equivalent uniform net-section stress. Normalized CMOD ($=\text{CMOD}/\text{Gage Length}$) was used to compare the creep deformation of the notched specimens with that from an unnotched specimen. Typical gage length for CMOD measurements was ≈ 9.68 mm.

Interestingly, the normalized CMOD is in the same range as the strain measurements from unnotched specimens, although the stress levels are significantly different. For example, the response of notched specimen with net-section stress of 100 MPa is similar to that of an unnotched specimen with stress of 150-160 MPa. This difference in stress levels implies increased notch-sensitivity under creep loading conditions. In contrast, fracture tests of Nextel720/AS by Buchanan et al. [16] exhibited only slight notch-sensitivity at 1100°C. Hence additional notched creep tests were conducted and compared with the unnotched creep rupture behavior as shown in Fig. 7.

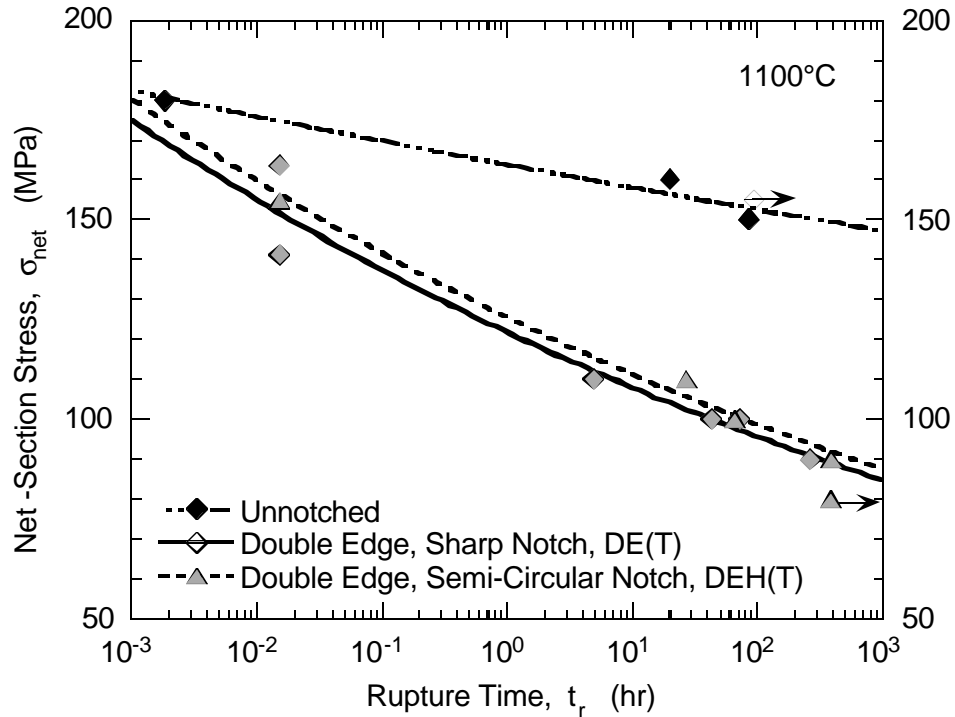
Figure 7. Notch effects on creep rupture behavior of Nextel720/AS (1100°C).

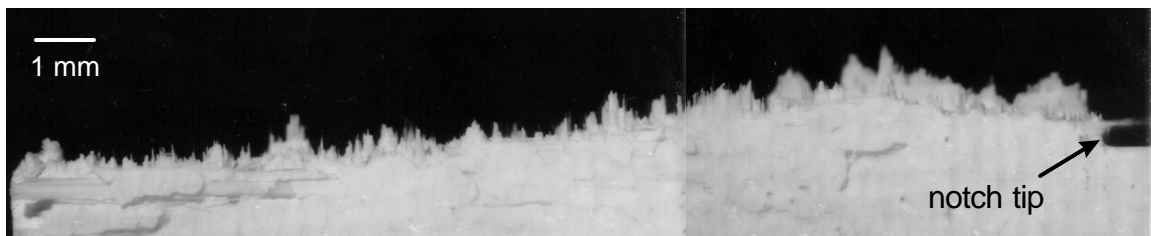
Figure 7. Optical fracture surface profiles for specimens tested at (a) 23°C and (b) 950°C monotonically loaded to failure.

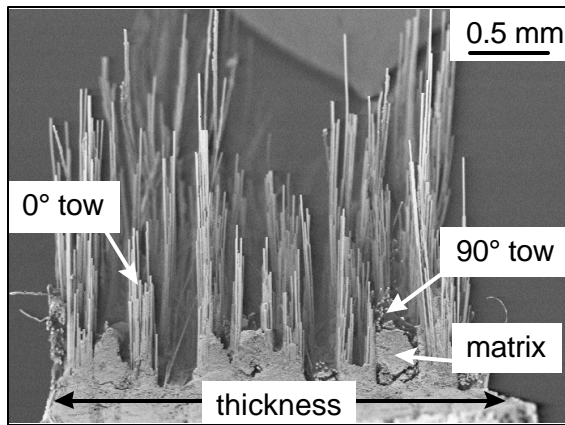
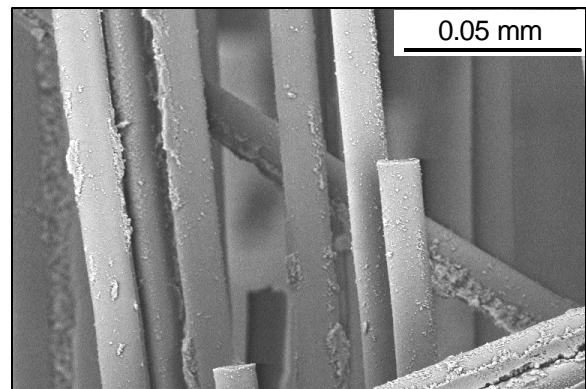
Figure 8. Scanning electron micrographs of room temperature fracture surface. (a) cross-sectional view of machined notch tip (b) top view of fracture surface (15° tilt from normal) (c) 0° fibers near primary crack plane (d) 0° fibers ≈ 1 mm from primary crack plane.

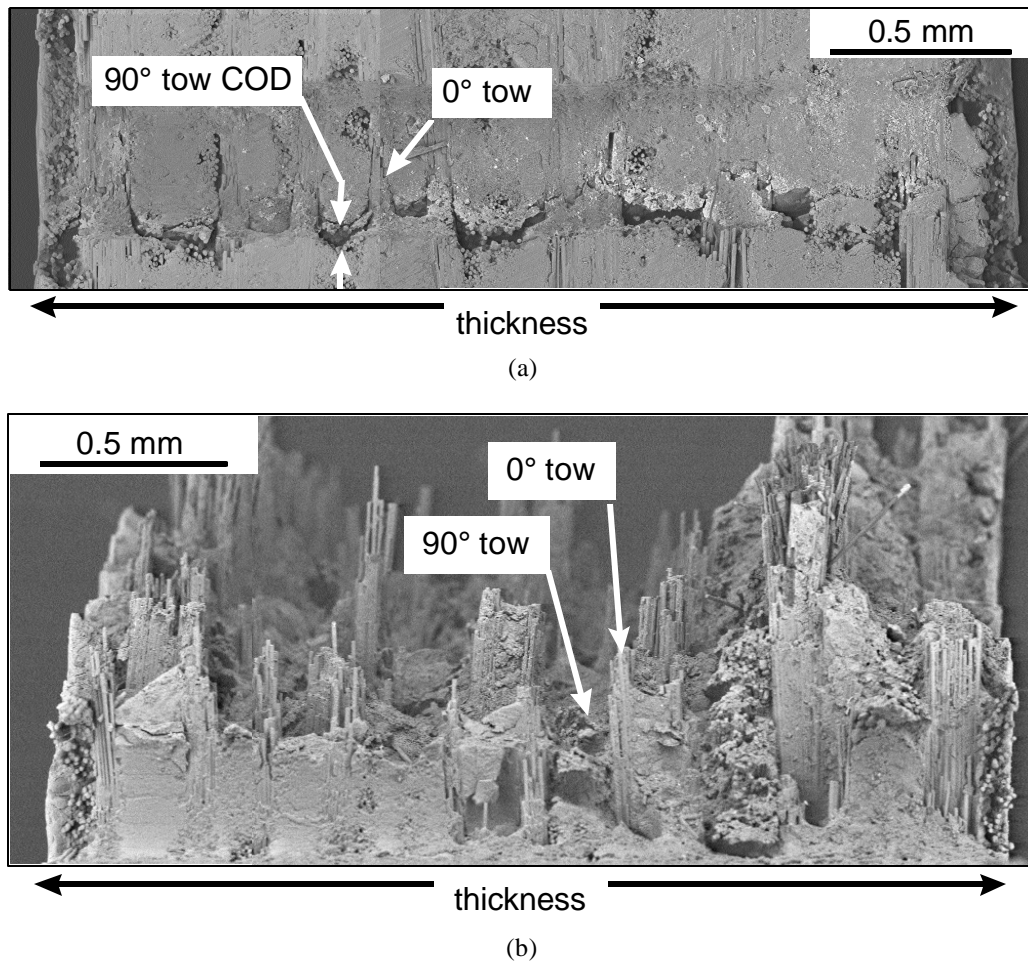
Figure 9. Cross-sectional view of machined notch tip region in 950°C specimens: (a) interrupted after the peak load (b) monotonically loaded to failure.

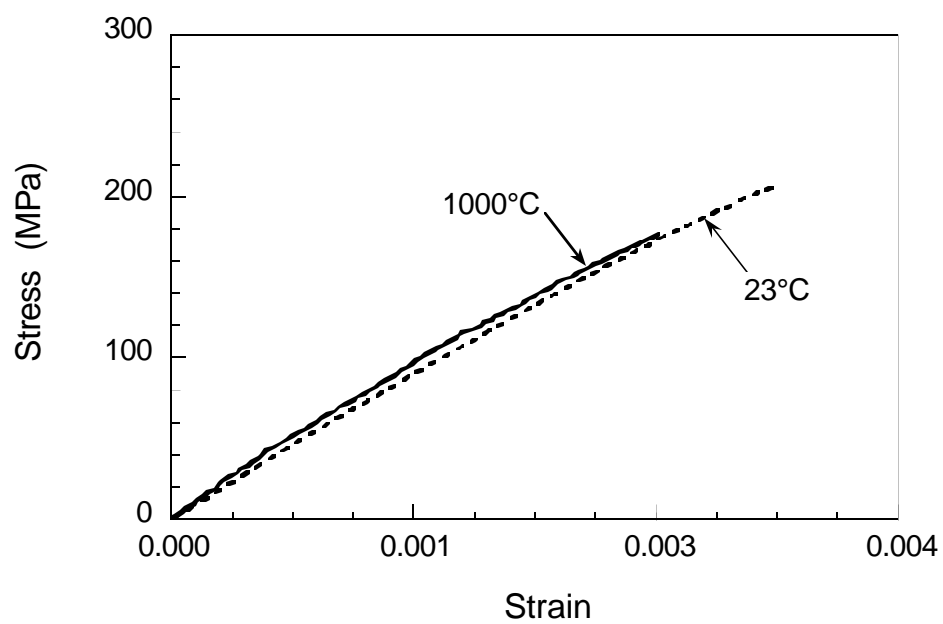
Figure 11. Tensile stress/strain response for unnotched Nextel610/AS at 23°C and 1000°C.

- Figure 11 Tensile stress/strain response for unnotched Nextel610/AS at $23^{\circ}C$ and $1000^{\circ}C$.
- Figure 12 Nextel610/AS unnotched tension fracture surfaces: (a) $23^{\circ}C$ (b) $1000^{\circ}C$ and details of matrix and 0° fiber behavior (c) $23^{\circ}C$ (d) $1000^{\circ}C$.

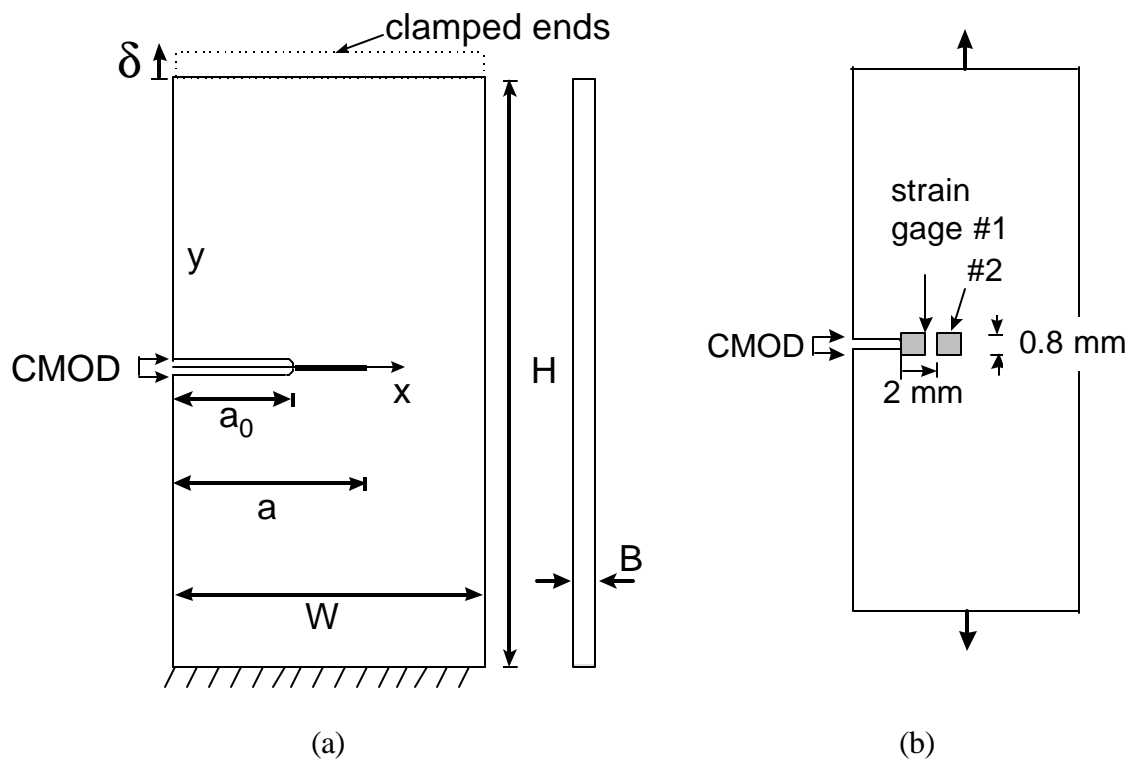
Figure 2. Schematic of (a) single edge notched specimen geometry, $W = 12.6$ mm at 23°C , 25.4 mm at 950°C , $B = 2.9$ mm and $H/W = 4$. (b) Strain gage locations for edge notched fracture tests. The lines within the gages indicate the direction of strain measurement.

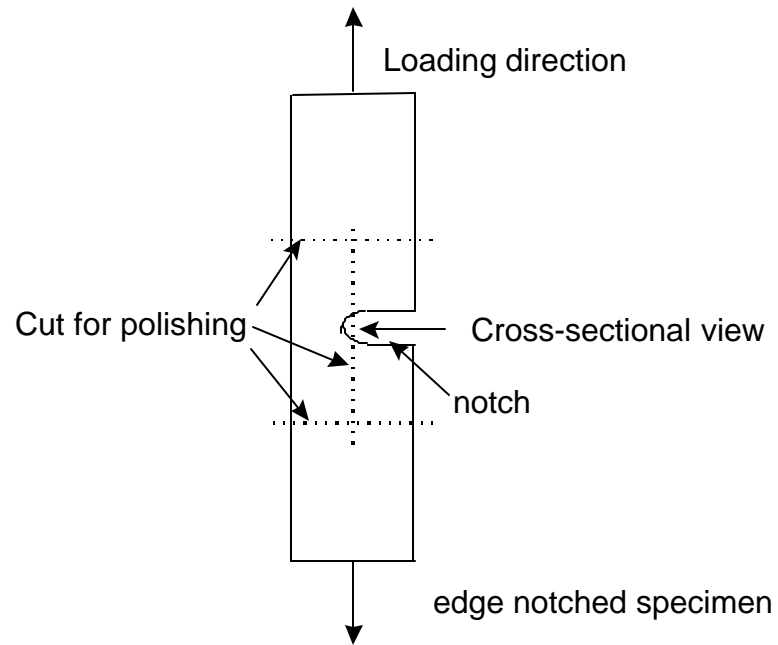
Figure 6. Schematic edge notched test specimen showing material removed for destructive evaluation of C-scan damage zone.

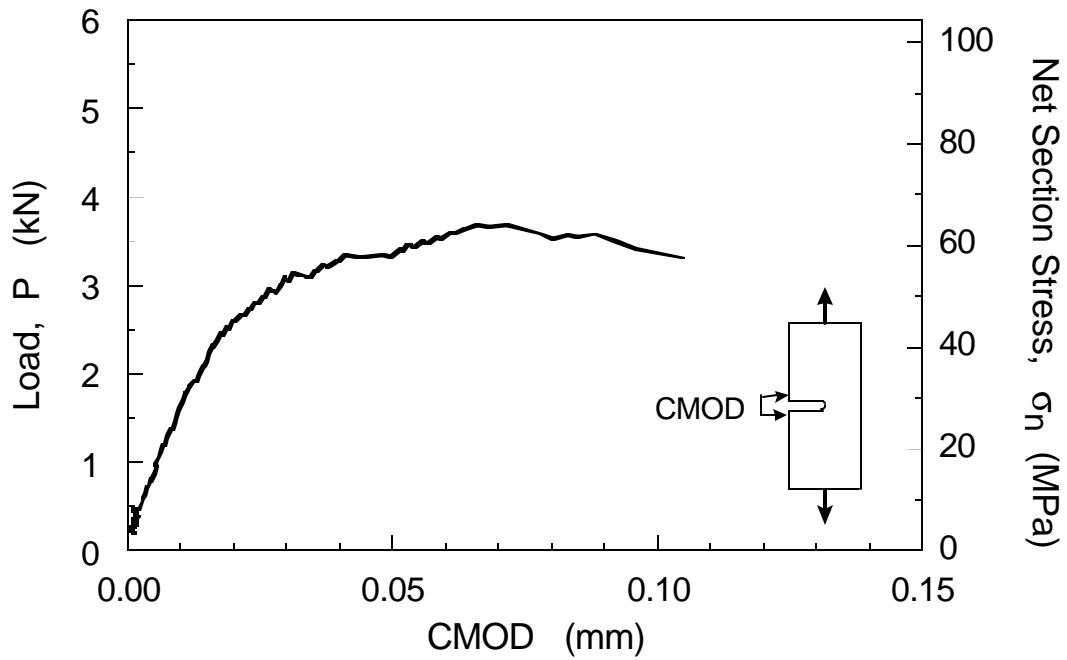
Figure 9. Typical load-CMOD response for an edge notched specimen, $W = 25.4$ mm, $a/W = 0.2$, 950°C .

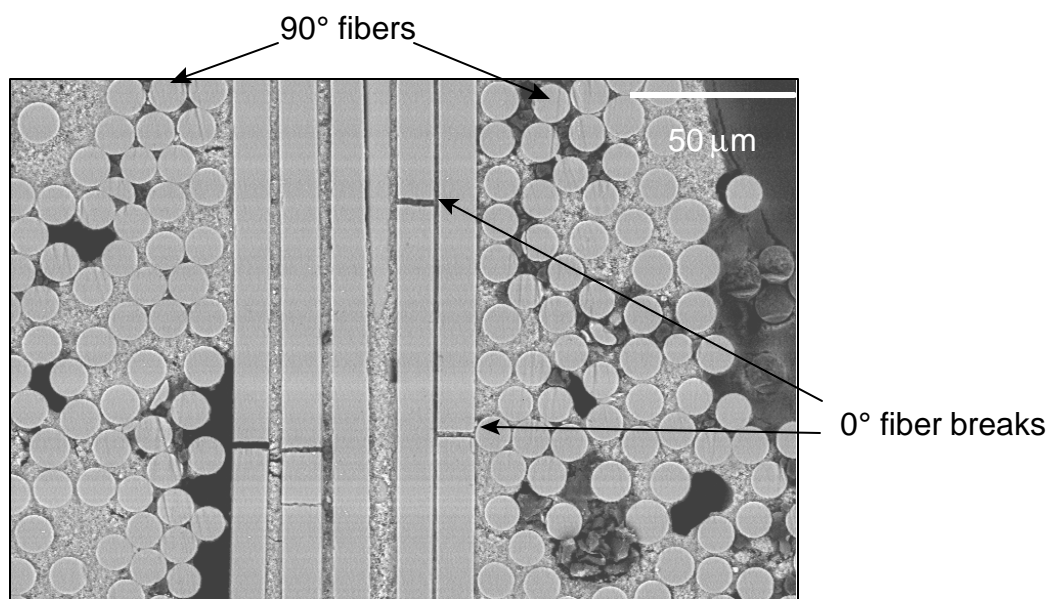
Figure 12. Polished cross section 14 mm ahead of the notch tip, 950°C.

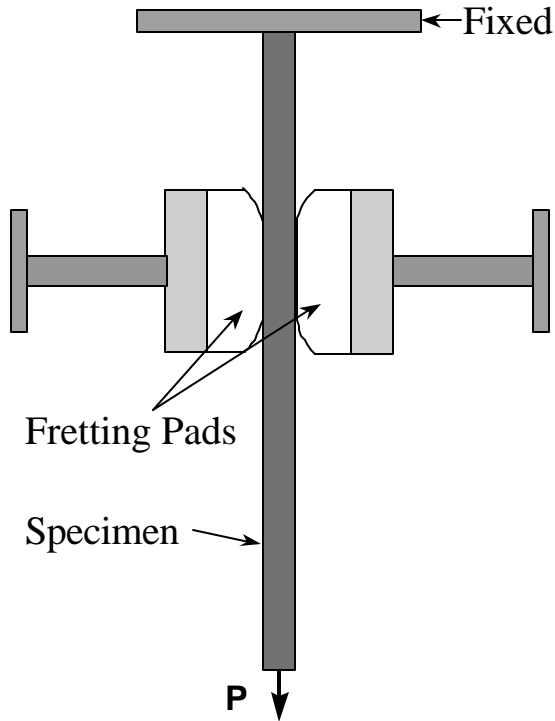
Figure 1. Schematic of a standard fretting fatigue apparatus.

The fretting fatigue apparatus used in both studies was designed to closely simulate the primary loading conditions under which fretting damage occurs in turbine engine blade attachment areas. A typical fretting fatigue apparatus, as shown in Figure 1, transfers only part of the load applied to the specimen through the fretting pads. The remainder of the load is transferred to the specimen beyond the fretting pads. This arrangement permits the investigation of the lower range of shear stresses, and facilitates residual strength testing after the application of a predetermined amount of fretting damage. The apparatus employed for the present studies, which will be referred to as the AFRL apparatus, allows all of the load applied to the specimen to be transferred through the fretting pads into the grip, leaving the ends of the specimen stress free, as would be expected in the extremities of the dovetail section of a fan blade. Such an arrangement ensures no gross slip for valid tests, and allows for the investigation of a higher range of average shear stresses. In the standard fretting fatigue apparatus, the average shear

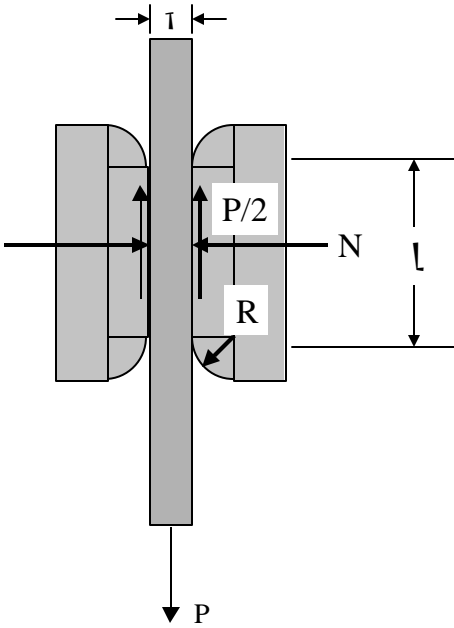
Figure 3. AFRL test nomenclature.

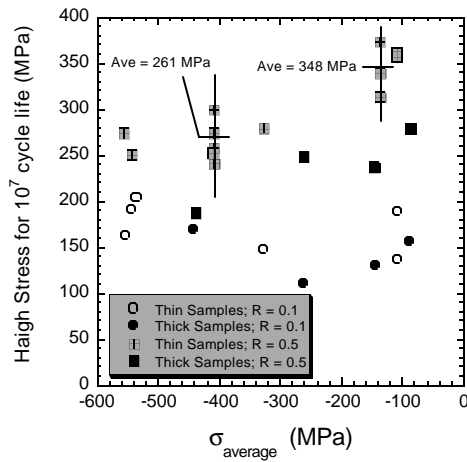
Figure 4. 100%-of-life test results, including some “effect of thickness” for comparison.

The results of the 100%-of-life tests are shown in Figure 4, along with the "effect of thickness" data. The data of immediate interest is the $R=0.5$ data for the thin samples. At 140 MPa average normal stress, the average fatigue strength is ~350

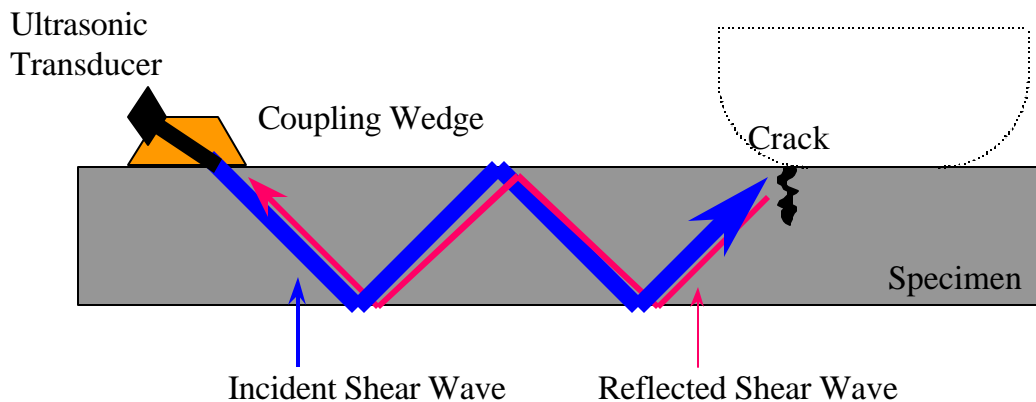
Figure 5. Ultrasonic crack detection using shear waves.

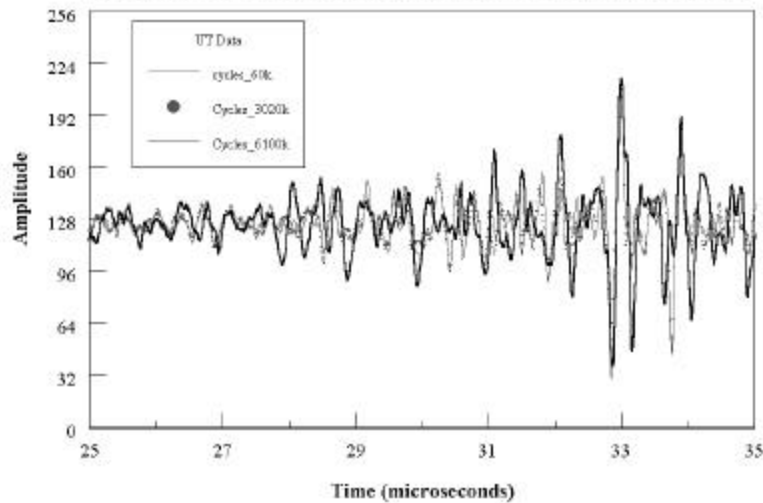
Figure 6. Ultrasonic shear wave detection of fretting fatigue cracks in Ti-6Al-4V.

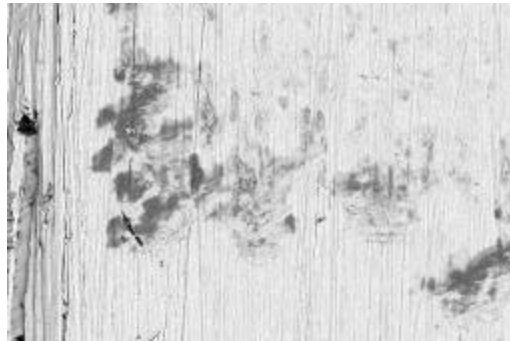
Figure 9. 10%-of-life damage for 140 MPa normal stress. Fatigue loading axis is vertical.

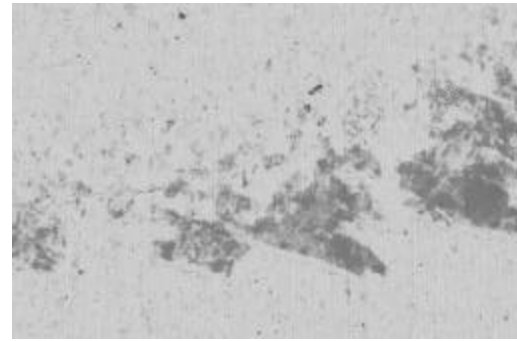
Figure 10. N_{det} damage for 140 MPa normal stress. ($N = 14,630,000$ cycles)

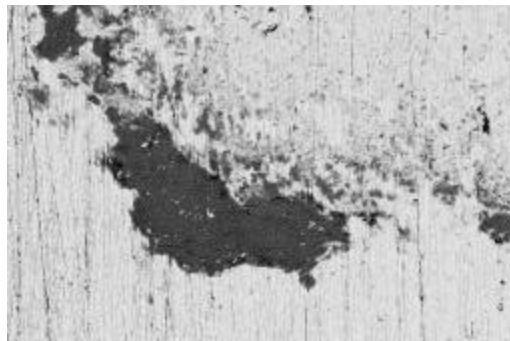
Figure 11. 100%-of-life damage for 140 MPa normal stress. Fatigue loading axis is vertical. ($N_f \sim 144$ million cycles.)

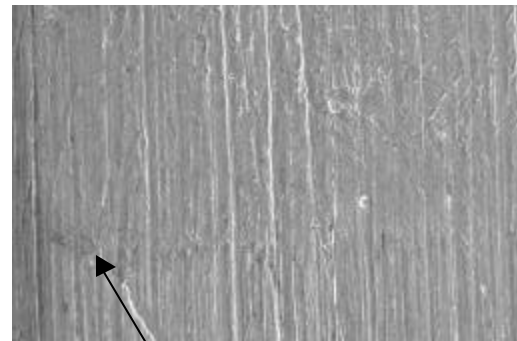
Figure 12. 1%-of-life damage for 420 MPa normal stress.

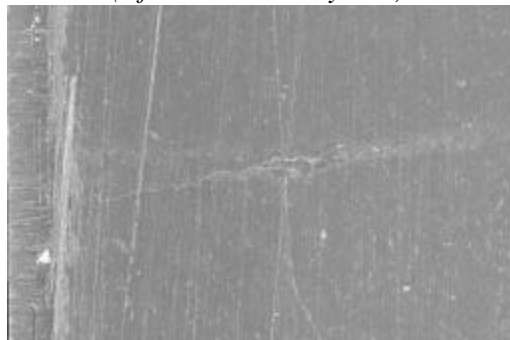
Figure 13. 10%-of-life damage for 420 MPa normal stress. ($\sim 1.1\text{ mm}$ crack)

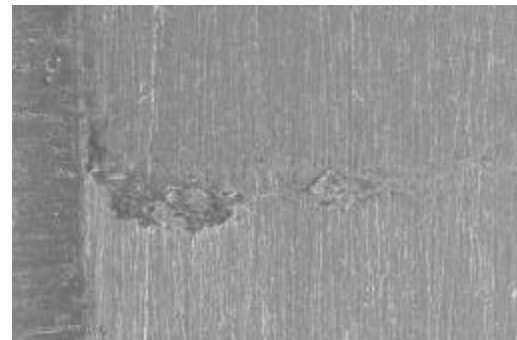
Figure 14. 100%-of-life damage for 420 MPa normal stress. ($380\text{ }\mu\text{m}$ crack)

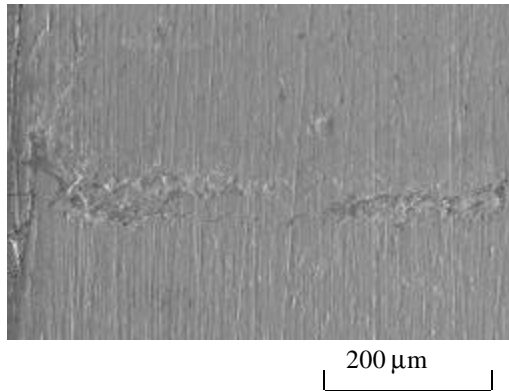
Figure 15. Secondary fretting crack nucleated at 420 MPa normal stress.

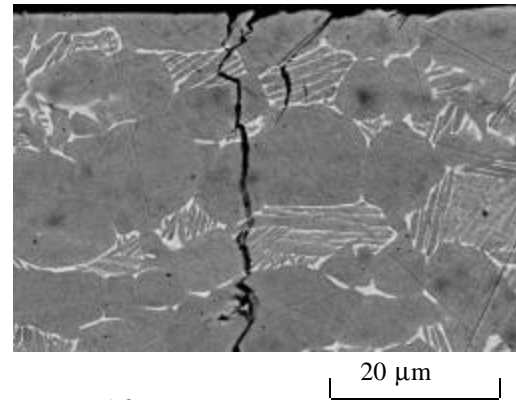
Figure 16. Cross-section of secondary fretting crack $\sim 600 \mu\text{m}$ from the specimen edge.

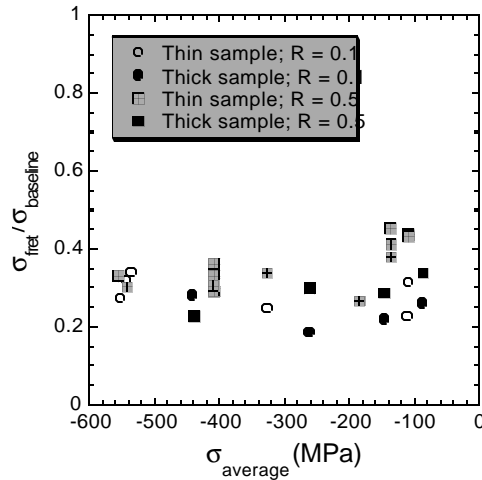
Figure 17. Comparison of normalized limit stresses for thick and thin samples vs. average applied normal stress.

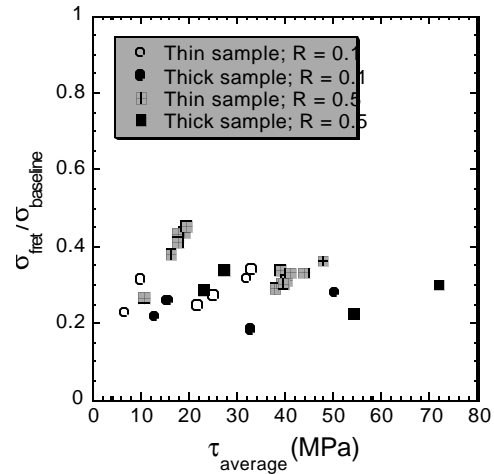
Figure 18. Normalized limit stresses for thick and thin samples vs. average applied shear stress.
